## OVERALL ASSESSMENT

## 2026 Toyota Corolla Altis

INSPECTION REFERENCE / REPORT ID

TXI-2026-000004

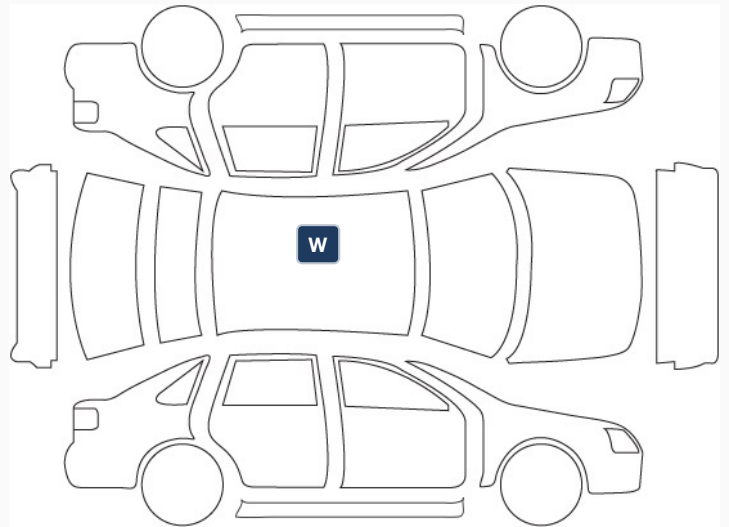
## EXTERIOR CONDITION MAP

| CODE | DETAIL | PHOTO |
|---|---|---|
| <b>W — Scratch — Minor paint scratch on the surface</b> | — | |
